Air Accident Investigation Authority

Loss of Control Inflight

Accident Investigation Final Report

Zlin-Z-242-L

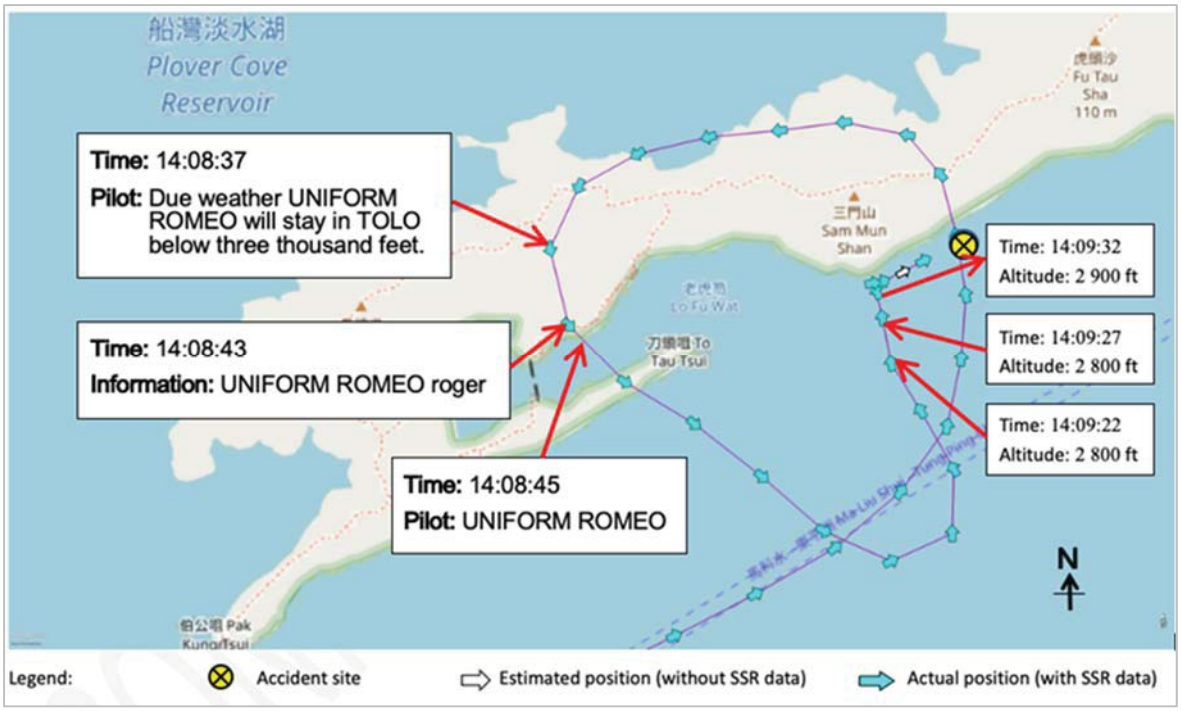
Figure 3 - Radar data with RTF transcript and headings prior to reaching 2,900 ft AMSL

At 14:09:37 hrs, the aircraft began descending rapidly.

At 14:09:57 hrs, the aircraft transponder was not detected by radar; the final transponder altitude interrogation indicated the aircraft was at 300 ft south of Plover Cove Reservoir in TOLO.

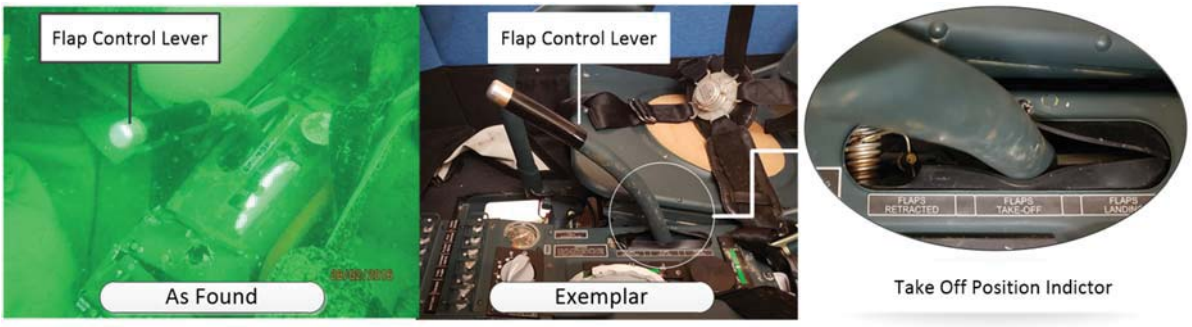
Figure 9 – (Left) Flaps control lever as found underwater. (Right) exemplar for reference

The photo taken prior to the wreckage recovery shows that the flaps control lever is not in the retracted position.

The position of the flap handle as found was between “Flap Retracted” and “Flaps Take-Off” when the wreckage was discovered under the water.

The position of the flap handle was found to be between "Flap Retracted" and "Flaps Take-Off" when the wreckage was discovered under the water.

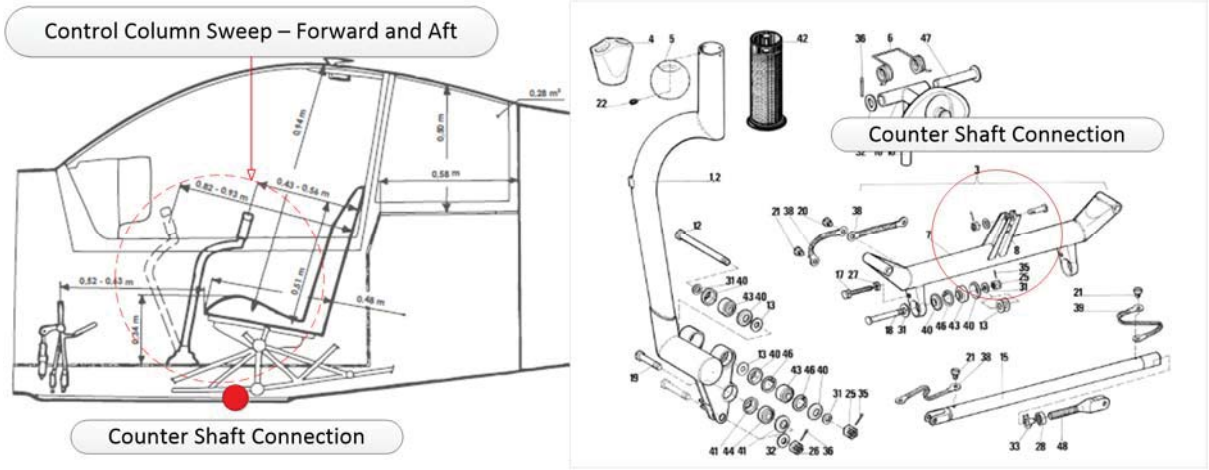
This deformation was found at about the middle of the forward side of the countershaft that connects laterally to both control sticks.

Figure 11 - Control Column Sweep and Counter Shaft Connection Location

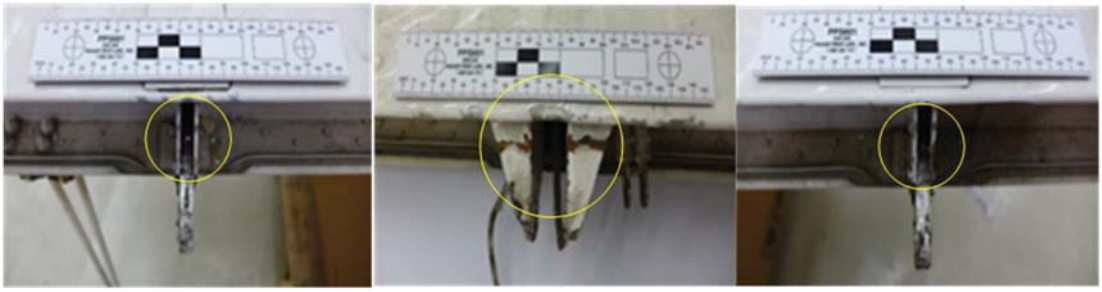
Witness marks were found on the top of the left, centre and right elevator support hinge brackets (Yellow outline).

Figure 13 - Witness marks on the top of all elevator support hinge brackets

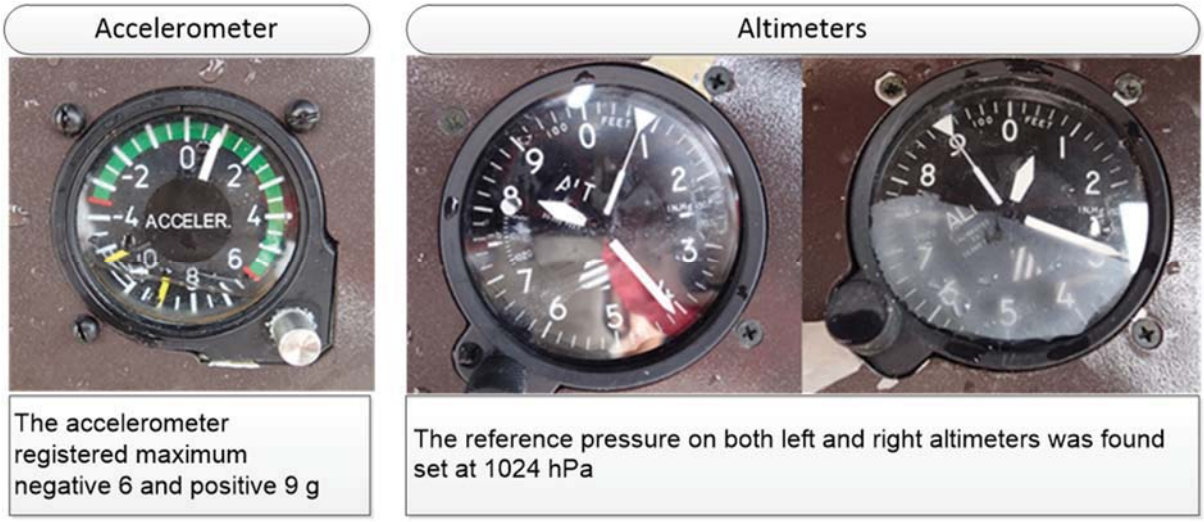
Accelerometer
Altimeters
ACCELER.
The accelerometer registered maximum negative 6 and positive 9 g
The reference pressure on both left and right altimeters was found set at 1024 hPa

Figure 16 - Instruments

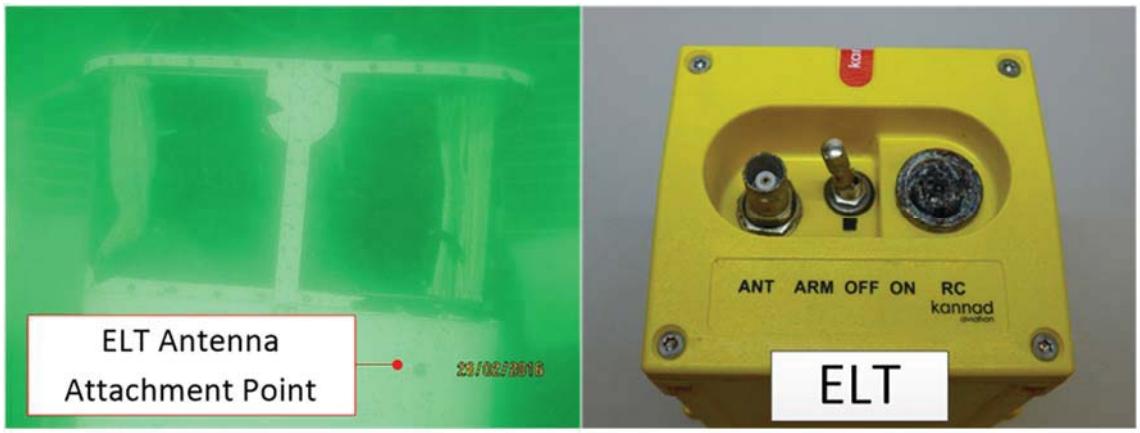
Figure 18 - ELT Location and ARM Switch

The photo on the left taken prior to the wreckage recovery shows that the antenna of the ELT has detached from the upper fuselage.

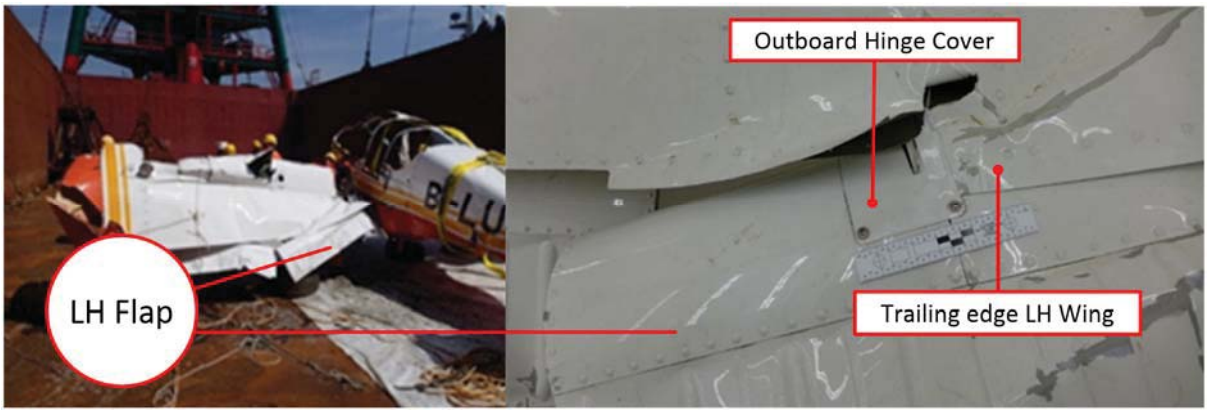
The non-uniform lateral deformation of the flaps in conjunction with the position of the flaps and the damage indicates the flaps sustained high energy damage due to impacting the sea during the rotation of the spin.

Figure 23 - Flap Damage

The trailing edge of the left wing is under the outer hinge cover of the flap.

There are no witness marks found underneath the trailing edge of the right wing, indicative that the flap was not in the retracted position (the flap has a flush profile with the wing at impact which would leave residual witness marks on impact).

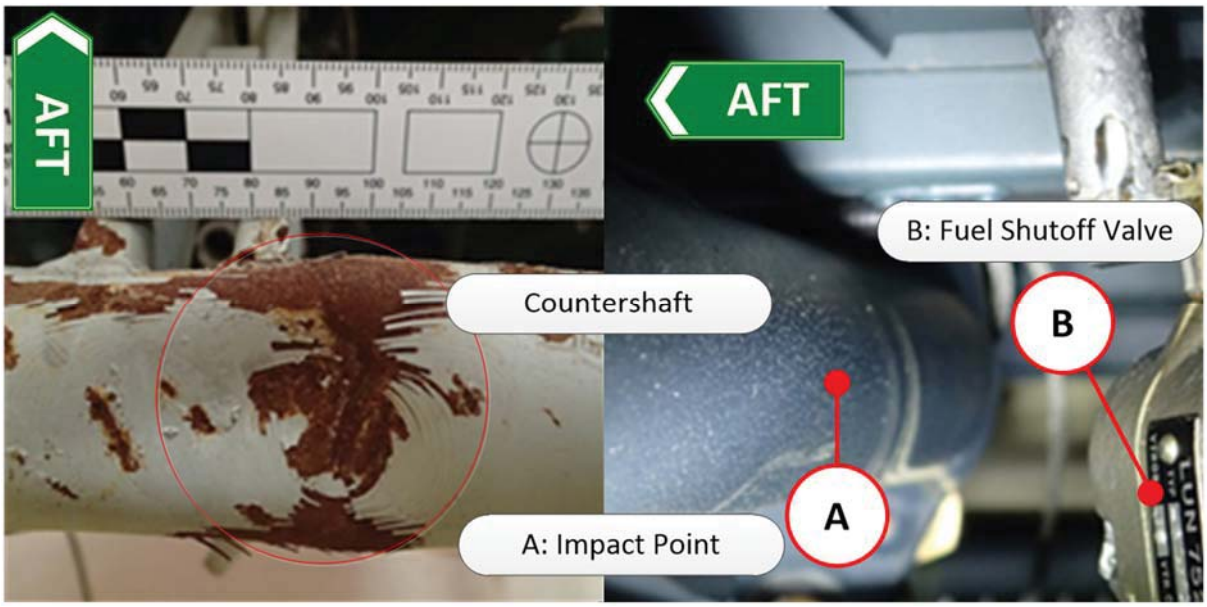
Assessment of the witness mark on the control stick countershaft (at impact) was conducted using an exemplar aircraft as reference.

Figure 24 - Control Countershaft Damage

The fuel shutoff valve is located on the same horizontal plane and directly in front of the countershaft.

It was found that only when the control stick was held at the full aft position, at which the relative position of the fuel shutoff valve and the countershaft would have matched the impact location of the witness mark, indicating the control column was at the full aft position at the point of impact.

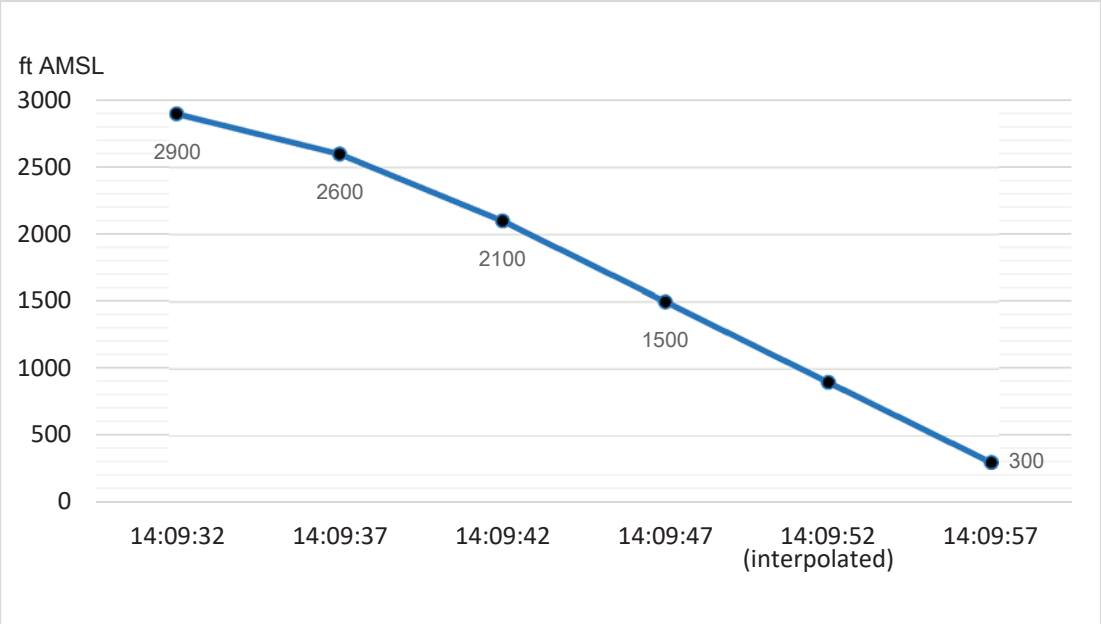
Table 5 - Descent Rate/Altitude (ft) vs Time (s)

Within the 20 s between 14:09:37 hrs and 14:09:57 hrs, the aircraft descended 2,300 ft, from 2,600 ft down to 300 ft AMSL at an increasing rate, with the highest rate of descent over 7,000 ft/min.

The last 300 feet was not recorded on the radar data, interpolation of the available data is linear with a constant rate of descent until impact.
